SAS Superstructure

Daily Diary Report by Bid Item

Diary #: 304 Const Calendar Day: 611 Date: 12-May-2011 Thursday

04-0120F4
04-SF-80-13.2/13.9
Self-Anchored
Suspension Bridge

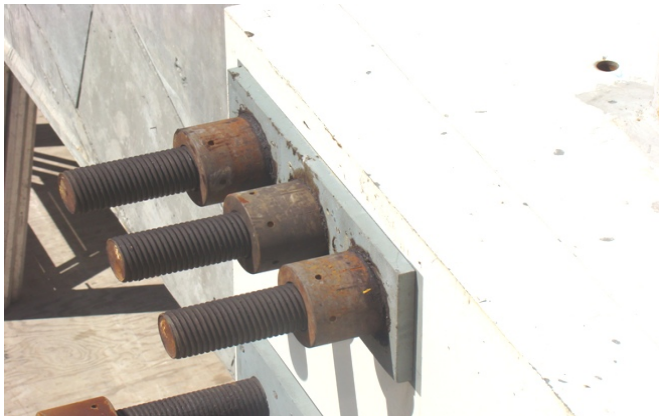
More Macalloy rod nuts at the W2E North Hinge K placed in the wrong direction.

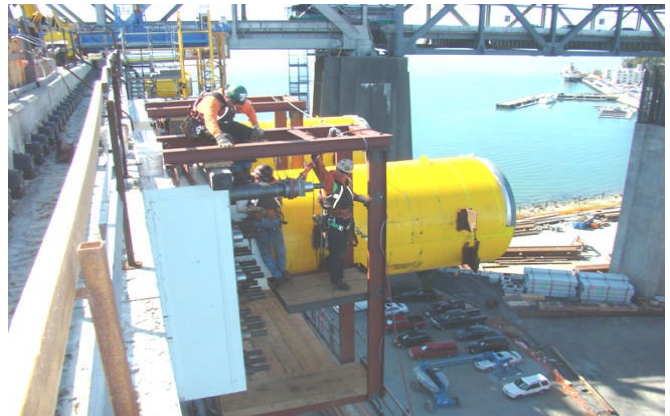
ABF ironworkers in the process of stressing the Macalloy rods of the North W2W Hinge K assembly.

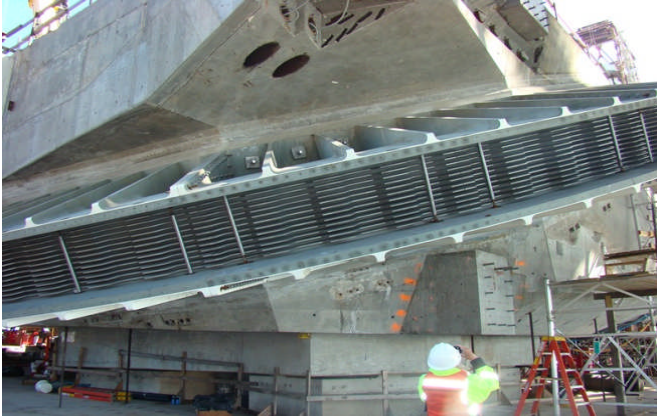
Erection gantries removed from the W2E west deviation saddles yesterday immediately after stressing operations were completed.

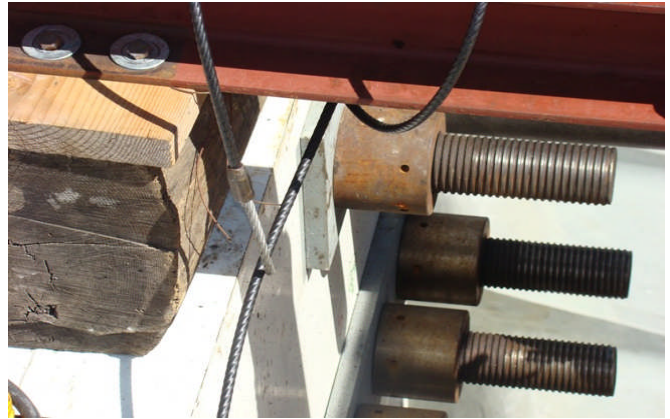
- Analyzed stressing procedures and performed independent elongation calculations for the Macalloy rods.
- Assisted Chris Havel with monitoring the Hinge K Macalloy rod stressing operation. It should be noted that 6 anchor rods in locations number 3 and 4 of the "Snugging" sequence for the W2E South Hinge K assembly had to be detensioned to turn the nut around. This was done due to the nut "divit" pattern was placed in the wrong direction. The "divit" pattern of the nut needs to be close to the bearing plates of the assembly box to enable the locking of the nut after stressing in the notched area of the jacking stool. ABF engineer Zach Lauria was onsite and aware of the issue during this part of the operation. There were other nuts that were previously "snug" against the bearing plates for this Hinge K assembly. These nuts potentially mitigated movement during destressing of the nuts that supported the dead load of the Hinge K assembly during erection and grouting. See photos below for more details.

A Macalloy rod nut at the W2E South Hinge K placed in the wrong direction, as the nut can't be tightened in the notch area of the jacking stool.

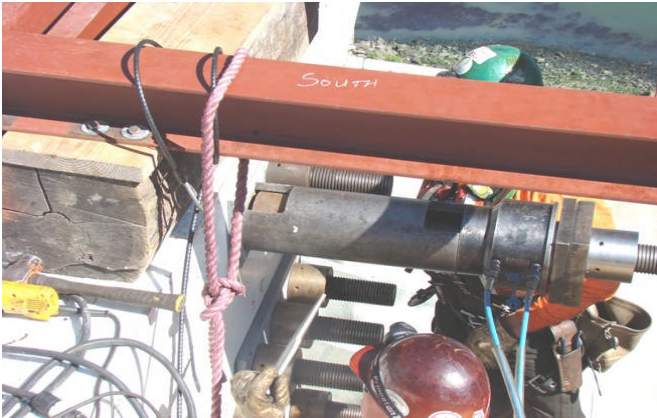
ABF ironworkers in the process of destressing a Macalloy rod at the South W2E Hinge K to turn the nut around so it can be tightened after stressing.

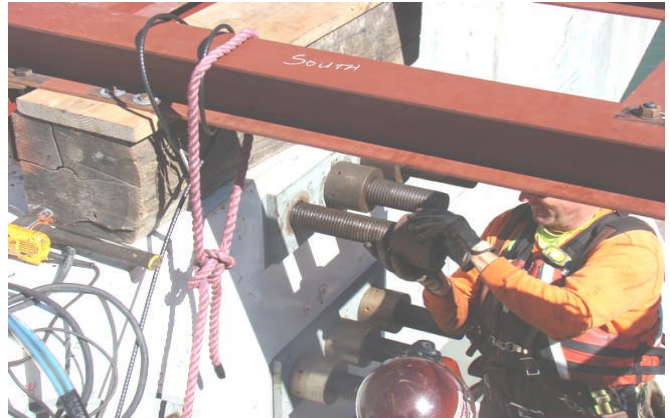
ABF ironworker placing the Macalloy rod nut in the correct direction at the South W2E Hinge K assembly.

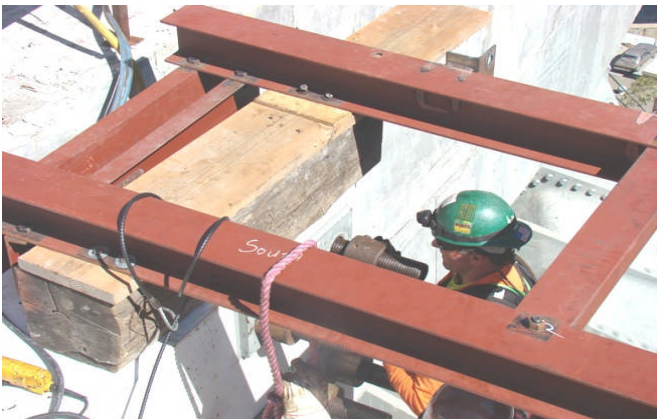
Destressed Macalloy rod nut being removed and the divit pattern in the nut is being placed near the bearing plate.

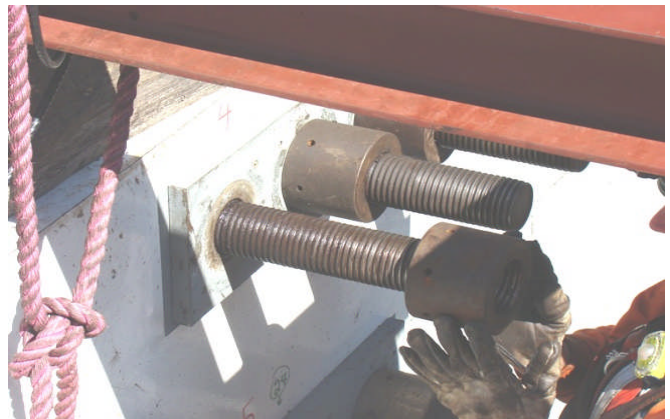
Closeup of Macalloy rod and nut being placed.
